Installation No.: 02TO
V1, 11-16-2010

Title: FRONT SIAB STRAP INSTALLATION NOTES

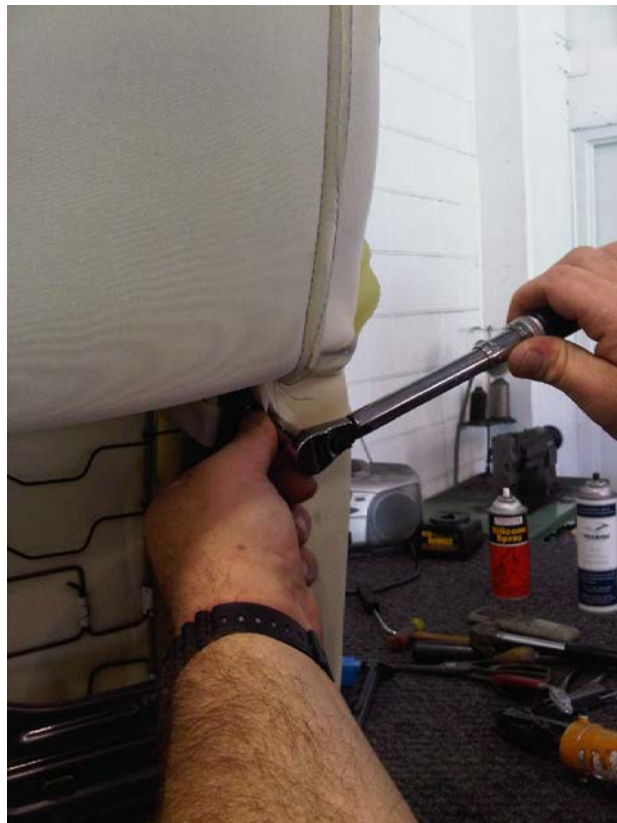
Photo 1.1

1. REMOVE THE NUT AND SEPARATE THE TWO BRACKETS (see Photo 1.1)

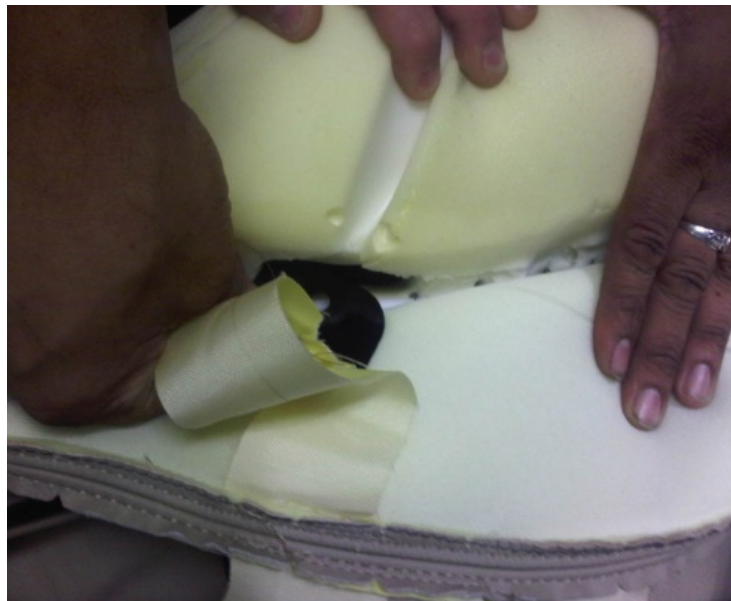
5. PROPERLY ROUTE INNER AIRBAG STRAP THROUGH THE OPENING BETWEEN INSERT AND OUTER BOLSTER (INSPECT STRAP TO BE SURE IT IS NOT TWISTED)

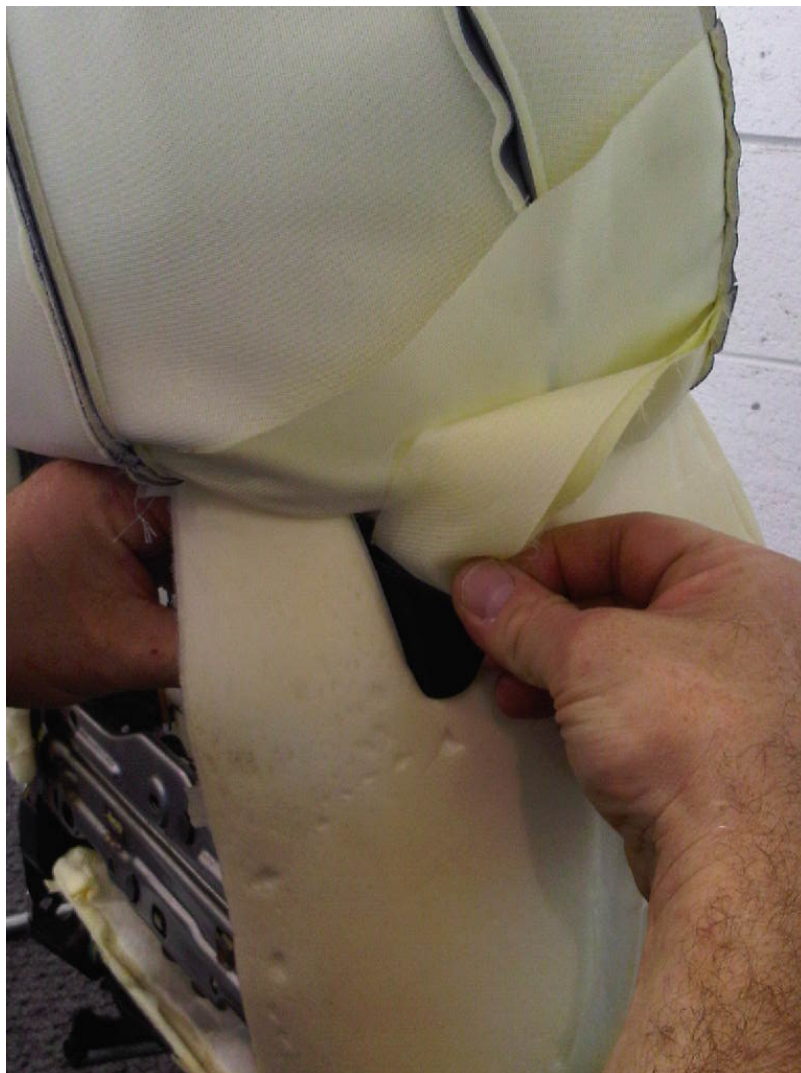
Photo 6.1

6. PROPERLY ROUTE OUTER AIRBAG STRAP THROUGH THE OPENING ON THE SIDE OF THE OUTER BOLSTER (INSPECT STRAP TO BE SURE IT IS NOT TWISTED AS SEEN IN PHOTO 6.1)

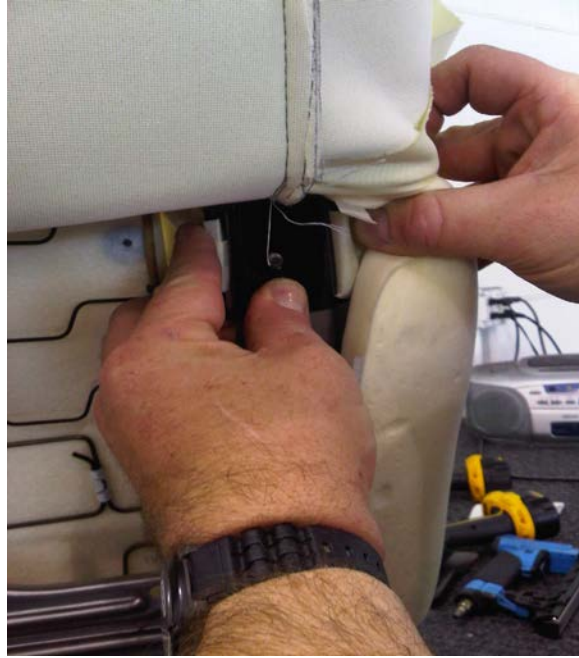
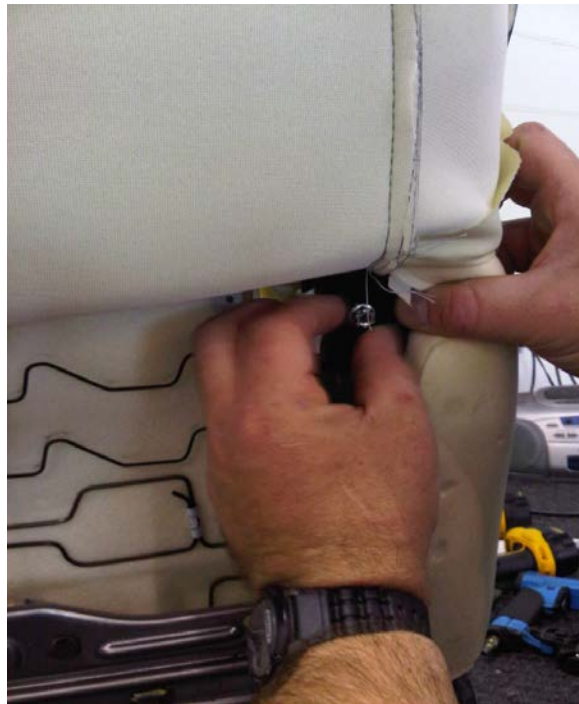
7. REINSTALL INNER AND OUTER BRACKET TO FRAME AND REINSTALL NUT AS SEEN IN PHOTO 7.1 AND 7.2.
